# Town of Arlington

## FINAL REPORT

### ADA Self-Evaluation (as basis for Transition Plan)

Prepared by  
Institute for Human Centered Design  
December 15, 2014

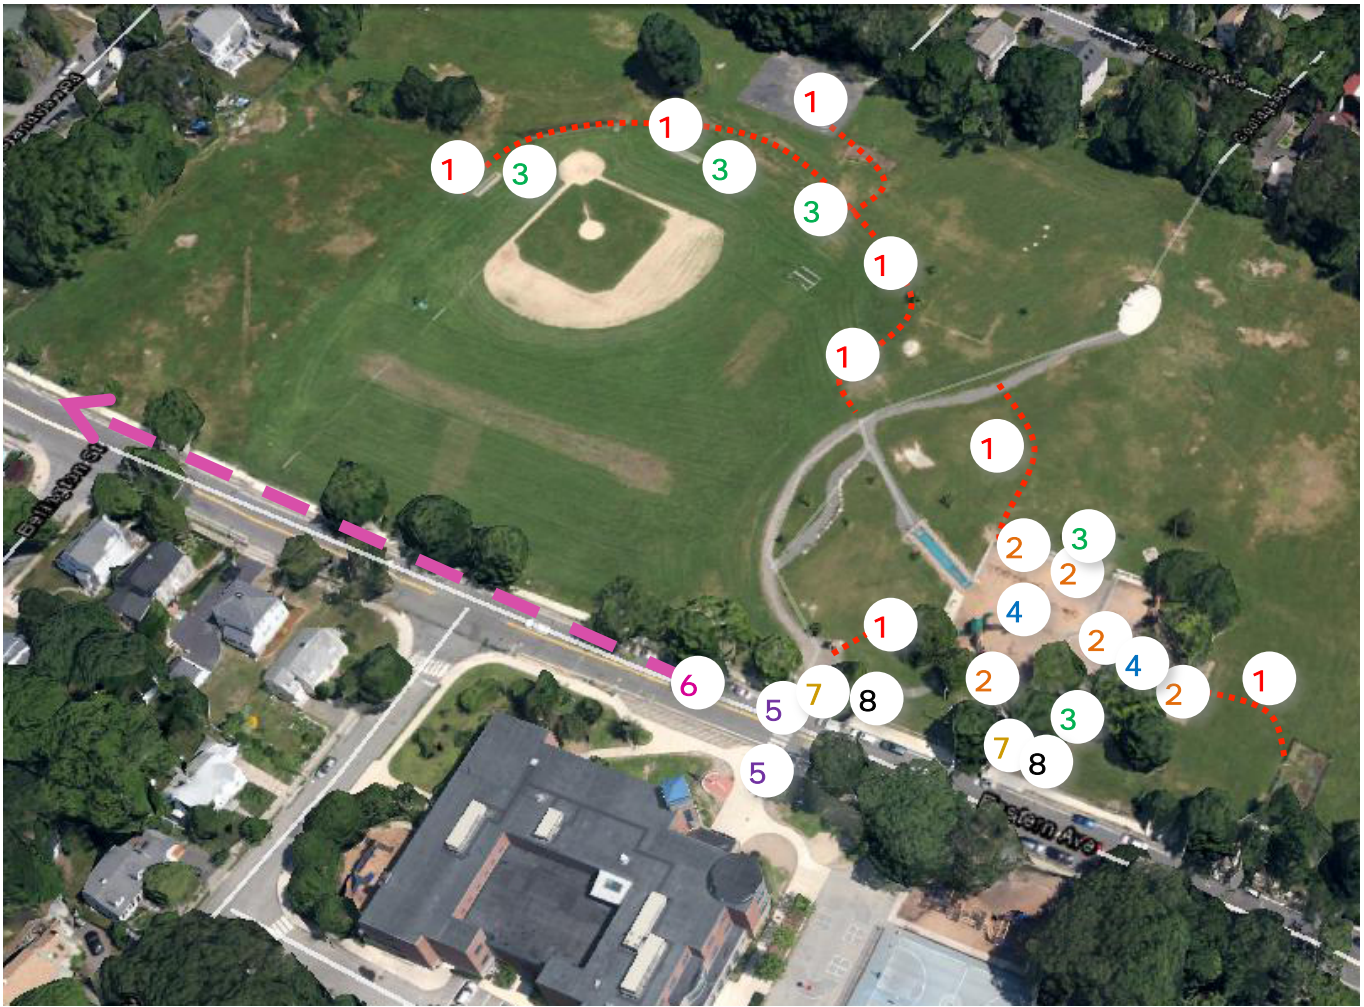
### **Robbins Farm ADA Recommendations**

- 1 Create at least one accessible walkway connection to all program areas, elements and amenities.
- 2 Establish entry/exit points between play areas and interior walkway.
- 3 Provide wheelchair seating location(s).
- 4 Replace or refresh ground surface materials for resilience and accessibility.
- 5 Mitigate curb ramp issues.
- 6 Connect facility to nearby public transit with accessible routes.
- 7 Place wayfinding signage at both interior walkway points of entry to show where each walkway leads.
- 8 Mount municipal notices between 40-70 inches above level ground area and along accessible route.

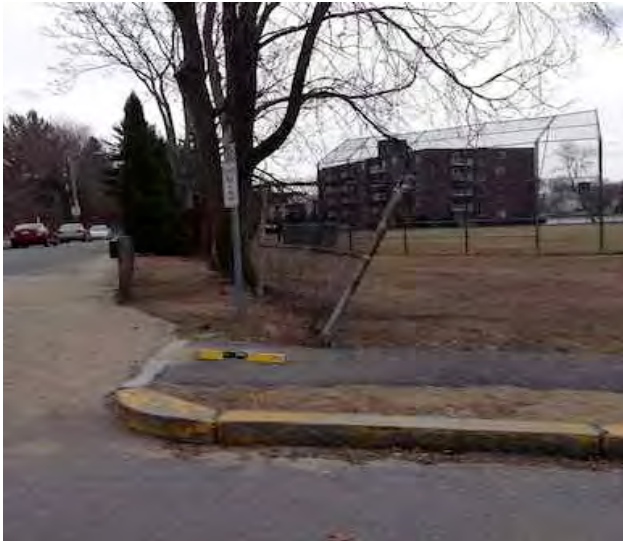
Photo 2

There is no accessible approach to the facility entrance because of missing curb ramps and uneven sidewalks. A curb ramp is missing at the southwest corner intersection, Hamilton St. and Linwood St. (Photo 2)

Construct an accessible pedestrian route from Mass Ave to Linwood Circle. Add curb ramps where missing.

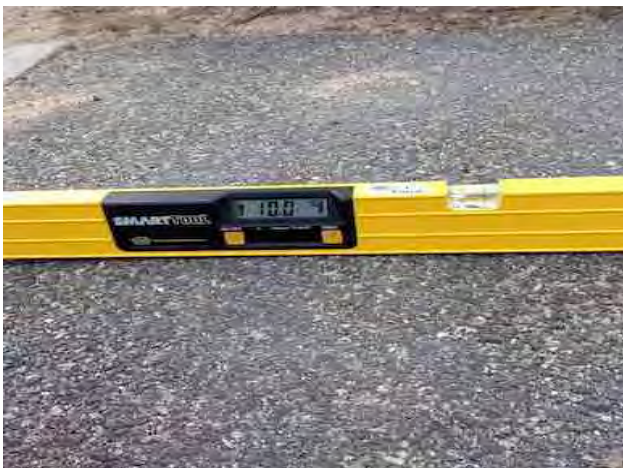
Photo 3

The sidewalk adjoining facility and around rotary has excessive slopes, and needs maintenance. (Photo 3)

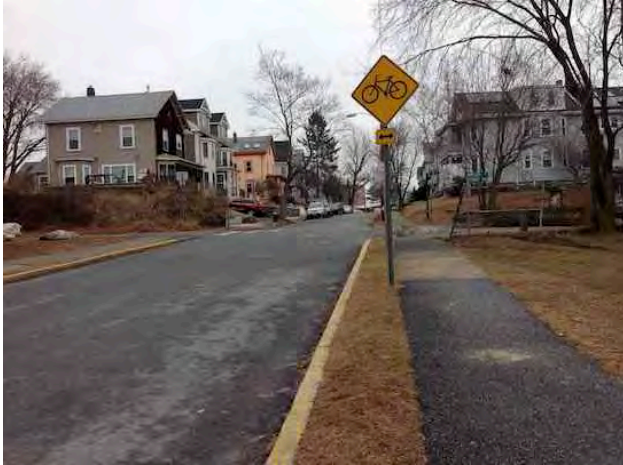
Photo 4

Due to curb ramp and sidewalk issues, there is not currently an accessible route from the Bikeway/shared-use trail link at the intersection of Linwood St. and the Minuteman Commuter Bikeway to Scannell Field. (Photo 4)

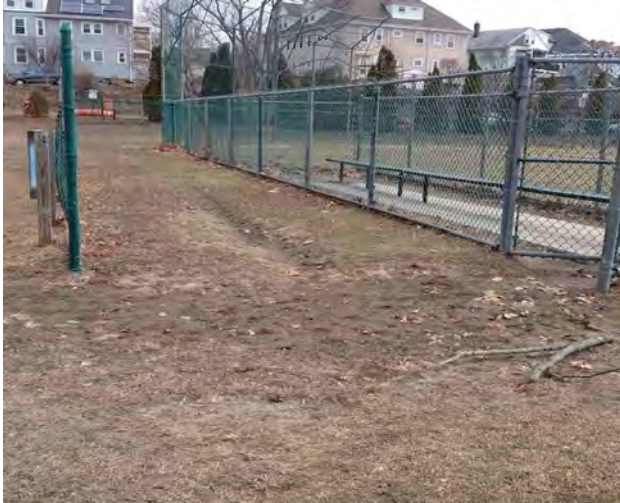
Photo 7

The ground surface is uneven instead of smooth, firm, level and slip resistant.

(Photo 7)

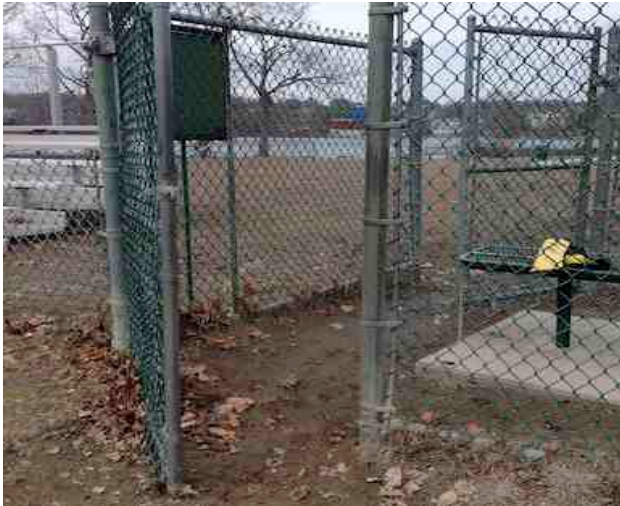
Photo 8

There is no accessible route to the perimeter of the field playing areas because the surface is not firm, level, smooth and slip-free. The routes to field from dugouts are narrow because the configuration of bench platforms and walkways in front and in back of benches in dugouts does not provide at least a 36 inch wide firm, level, smooth and slip-free route to field playing areas.

(Photo 8)

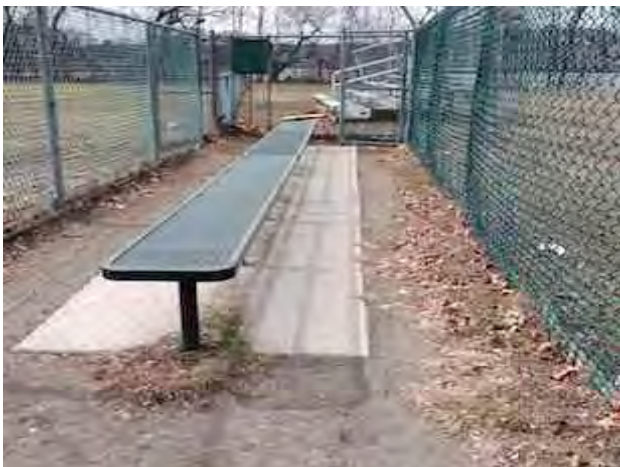
Photo 9

There are no accessible routes within the team seating areas. There is no accessible integrated wheelchair seating location within dugouts. (Photo 9)

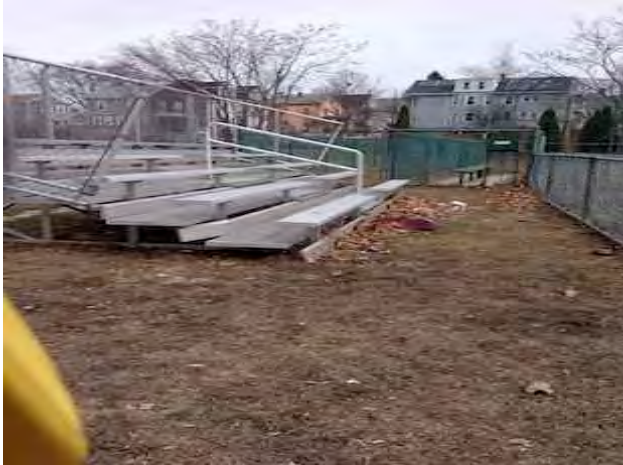
*Photo 10*

These bleachers are at the field year-round, and were surveyed as a fixed-seating element.

The bleachers are not connected to an accessible route and do not provide any integrated accessible wheelchair seating locations. (Photo 10)

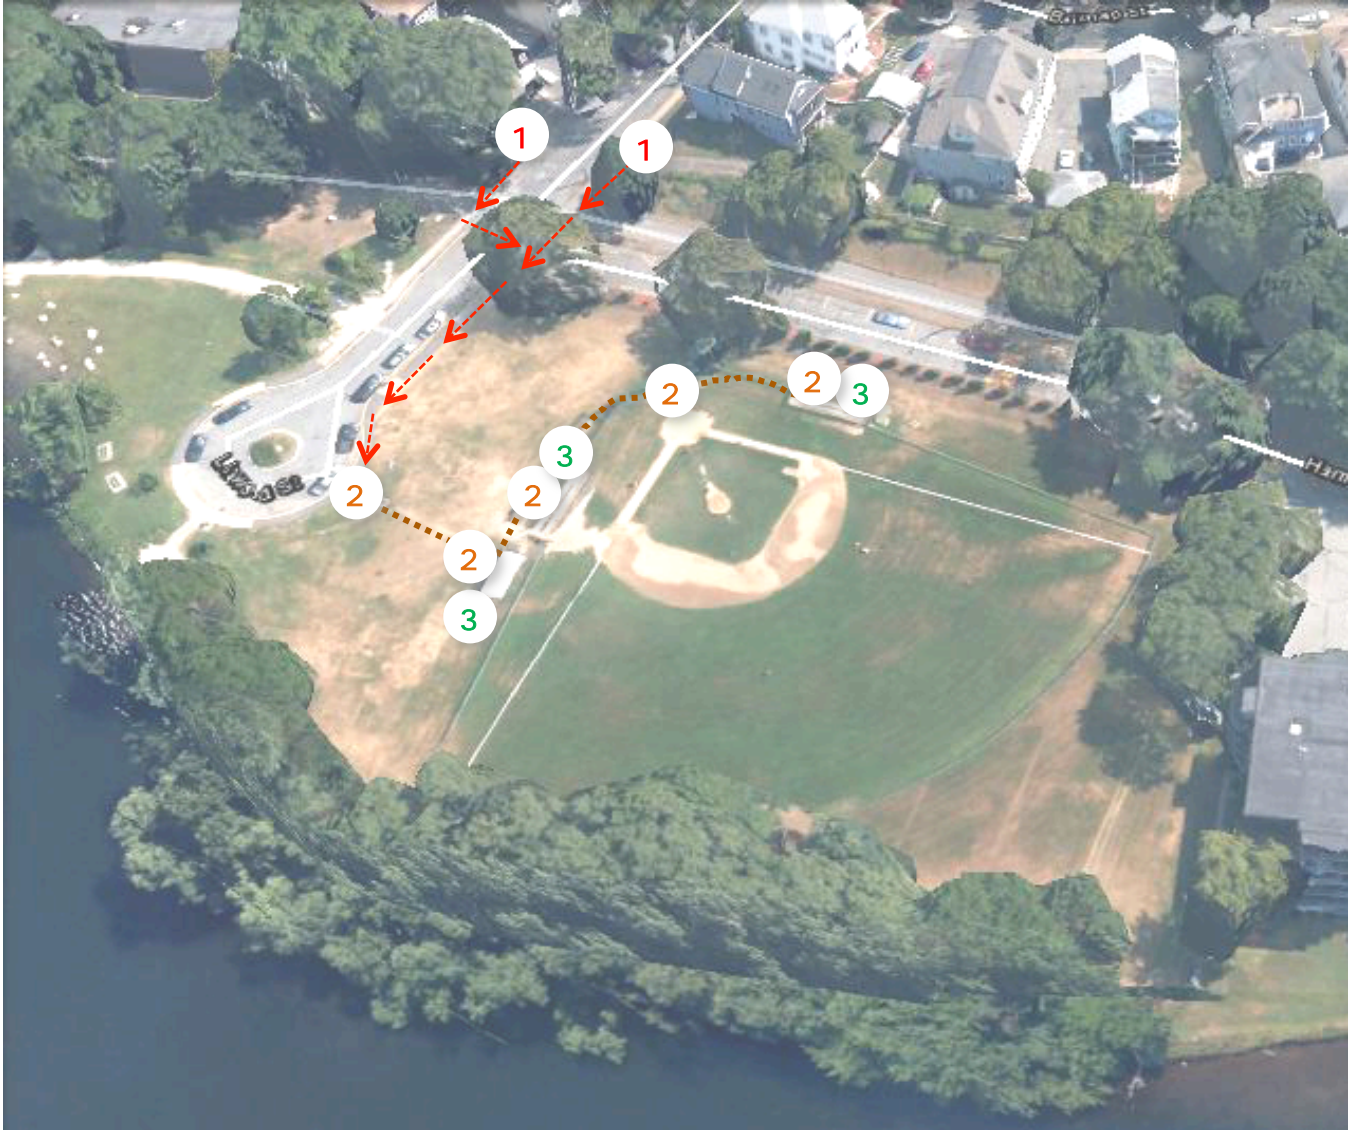
### **Scannell Field ADA Recommendations**

- 1** Create an accessible route from nearest public transit stop to facility.
- 2** Provide at least one accessible route that connects sidewalk to facility signage, entry gates, home and away-team seating areas, bleacher area, any public-use field gates, and any amenities, such as season portable toilets and drinking fountains.
- 3** Provide wheelchair seating locations at benches and bleachers.

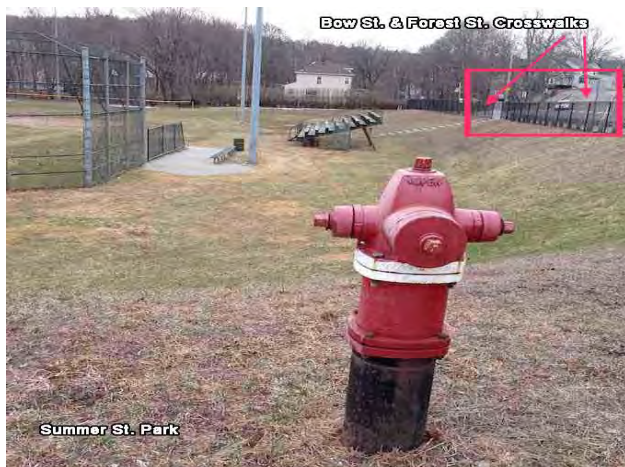
Photo 1

Summer St. Park has two points of entry at Forest St. and both entries have staircases and no accessible points of entry. The staircases lack handrails on either side and do not adjoin an accessible route from entry to boundary of sports playing fields, team seating area and bleacher areas. (See Photos 1 & 2)

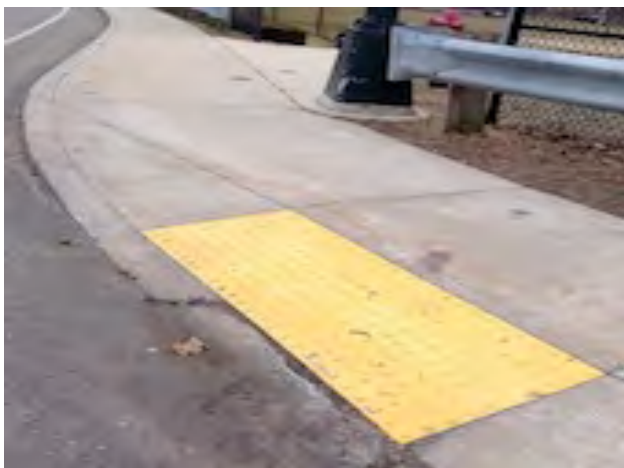
Photo 3

- Excessive cross slopes at sidewalk panels adjacent to three Accessible Pedestrian Signal controls (APS);
- Curb ramps are not oriented into crosswalks;
- Excessive cross slopes in sidewalk routes between new curb ramps;
- Sidewalk joints over 1/2 inch width; and
- Curb ramp transitions at gutter are in disrepair. (Photo 3)

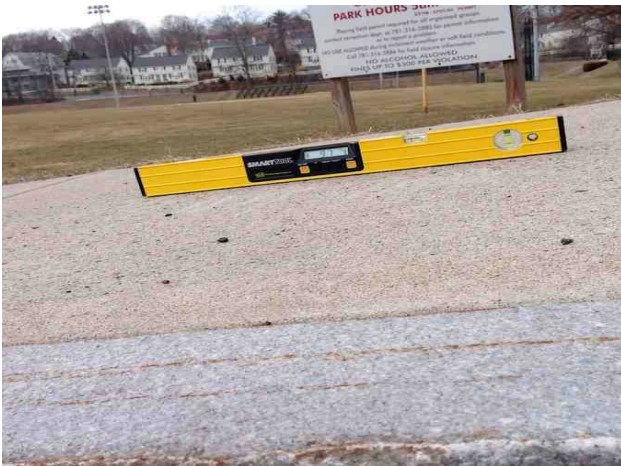
Photo 5

Due to natural terrain issues, this sidewalk needs to be ramped, with handrails. Cross slopes can be mitigated to compliance; run slopes will exceed 5%. (Photo 5)

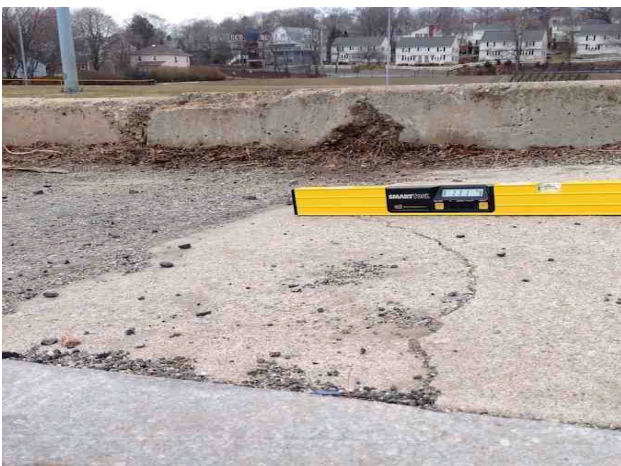
Photo 6

The line of work for this sidewalk ends prior to the Summer St. point of entry and the stone dust path does not provide an accessible site arrival point into the Park. (Photo 6)

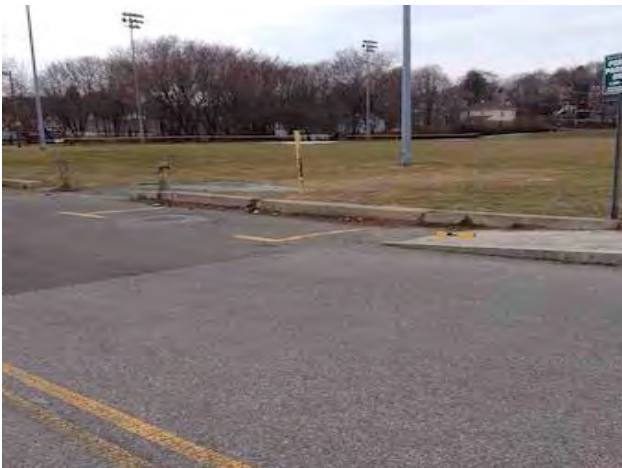
Photo 7

On Summer Park facility side, sidewalk ends prior to facility point of entry (between two small pillars). A parking space is marked in front of sidewalk, thus obstructing pedestrian routes from sidewalk into Summer St. Park entrance. (Photo 7)

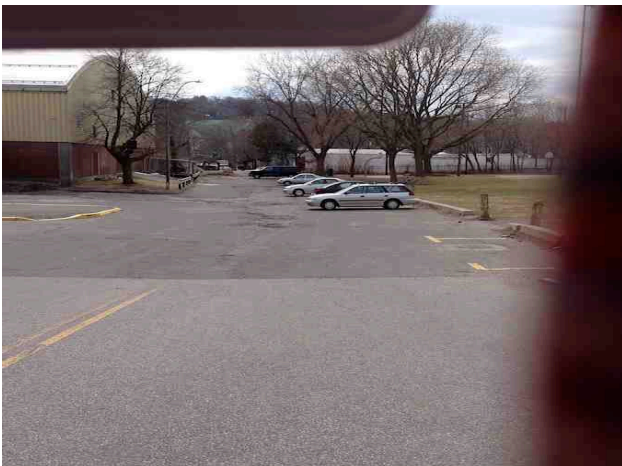
Photo 8

Beyond this entry point are approximately 12 additional parking spaces adjacent to Summer Street Park that are not connected by a pedestrian accessible route to Summer Street Park or to any of the facility entry points and amenities within the Sports Complex, including the perimeter sidewalk around the Ed Burns Arena. There is no designated van-accessible or accessible parking space along this group of parking spaces. There is no pedestrian accessible crossing route between this parking area and other pedestrian routes, bikeway connections, and outdoor areas within the Sports complex. (Photo 8)

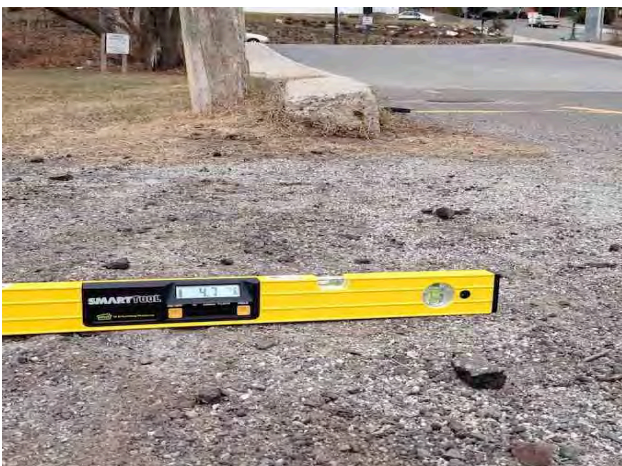
Photo 9

Along Ryder Street, marked point of entry is an eroding stone dust path. This path has excessive cross slopes and does not connect via an accessible route to any other facility program areas. (Photo 9)

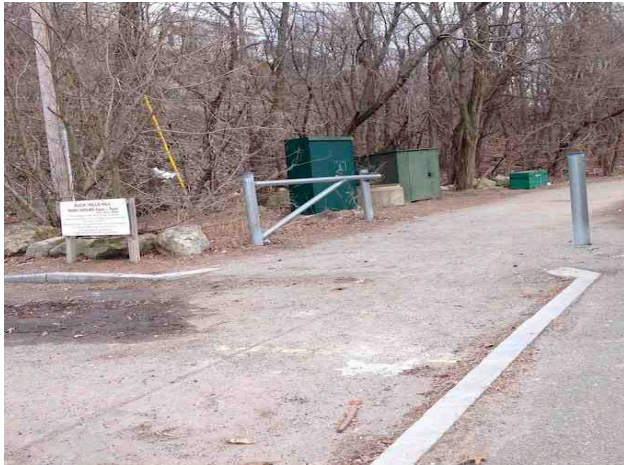
Photo 19

This point of entry is used as a service entrance for maintenance and needs to provide a smooth, level, firm, slip free route without water and other weather event accumulation. There are currently no accessible route components provided at this point of entry. (Photos 19, 20)

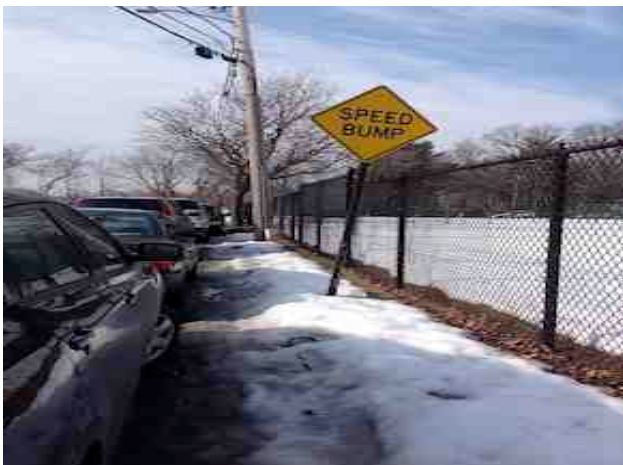
Photo 3

South and southeast facility entry points are not located along any accessible routes, and sidewalks are incomplete or missing. (Photo 3)

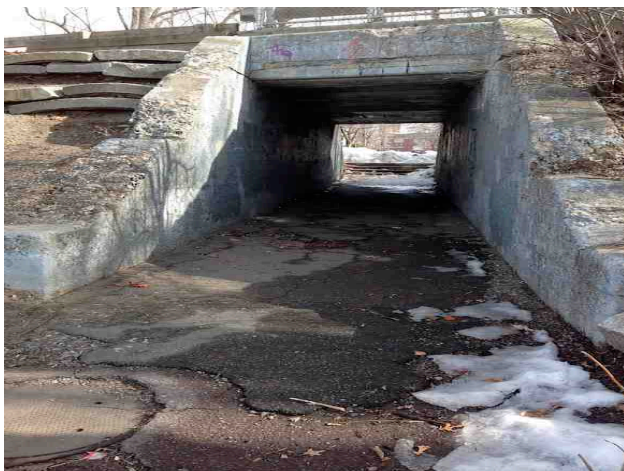
Photo 5

A pedestrian connection from the end of Whittemore Street via the tunnel/walkway onto the facility southeast paved field walkway includes 4 stone-slab stairs with approximately 7-inch risers but no accessible or ramped route. (Photo 5)

1. Fence opening onto an interior walkway, with Dog Walk Rules sign (Photo 9);
2. At the end of Whittemore Street via the tunnel/walkway onto the facility southeast paved field walkway (Photo 5); and
3. Pathway from the shared-use Minuteman Bikeway trail above field, which connects onto facility SE field walkway. (Photo 10)

A long-range recommendation is for the 4-stair entry at the Whittemore St. underpass to be replaced with a ramped accessible entrance onto facility SE field. (See Photo 5, above)

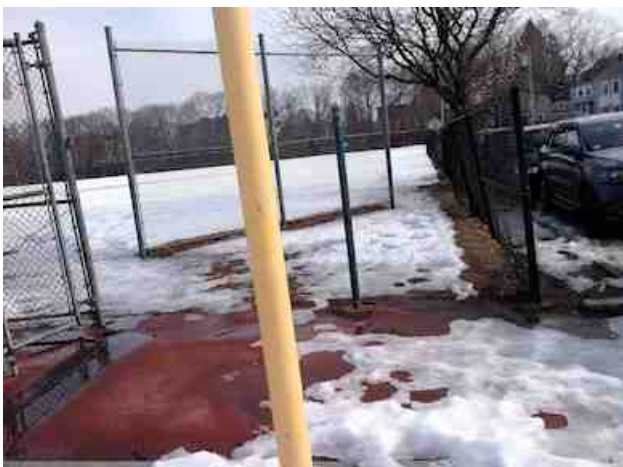
Photo 8

Two public gated entry points from public streets to facility are not along an accessible route and do not provide smooth, firm, level and slip-free ground surfaces. West Tennis Court gate does not open to at least 32 inches. Pond Lane gate approach is obstructed by on-street parking, lack of sidewalk route, and a paved entryway that is in disrepair with excessive cross slopes and tripping hazards. Gates require smooth surface or kickplate on push side. (Photo 8)

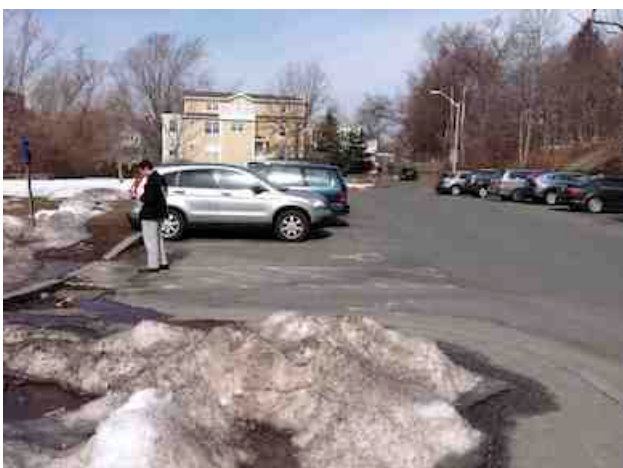
Photo 3

A curb ramp is provided at the North Beach Parking Lot in front of the 2 HP-designated spaces that share an access aisle. This inaccessible element has excessive cross slopes, excessive gaps and excessive level changes at gutter-to-ramp and ramp-to-sidewalk transitions. It lacks clear turning space and leads to a sidewalk with excessive slopes. (Photo 3)

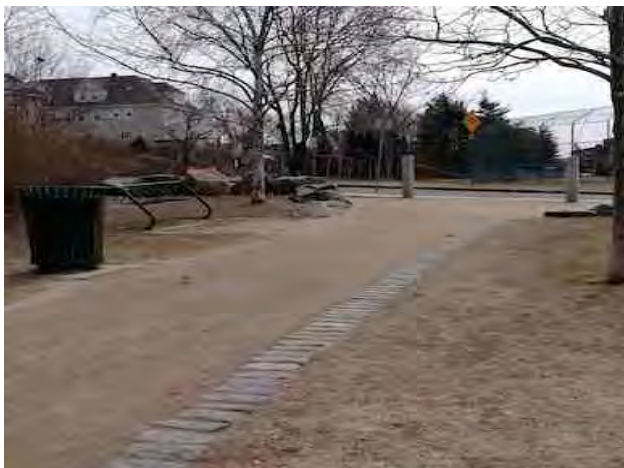
Photo 12

Point of entry to the South Beach Shoreline path is not accessible because the lengthwise cobblestone border at the head of the trail, similar to the head of the path from the North Beach, does not provide a level, smooth and slip-free transition between the Linwood Circle sidewalks and the graded shoreline path. This continuous edging also acts as a barrier to access the tables, benches, some trash receptacles and other viewing amenities along the length of the shoreline path. (Photo 12)

North Beach At head of Shoreline path at bollards gate, design and install solution to uneven surface caused by embedded cobblestones at point of entry.

South Beach At head of Shoreline path at bollards gate, design and install solution to uneven surface caused by embedded cobblestones at point of entry.

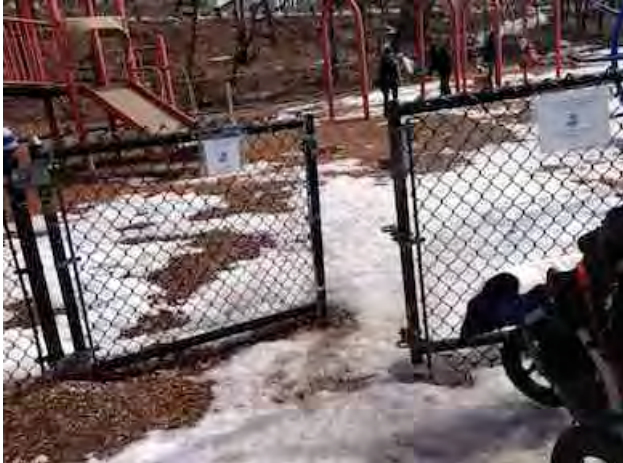
Photo 13

The Playground gate entrance, at North Beach, has an uneven, unstable ground surface, which accumulates water. There is inadequate clearance width at the opening because the ground surface includes uneven areas that hinder a 90-degree swing of the gate. Gate requires a smooth surface or kickplate on push side (2010 requirement). (Photo 13)

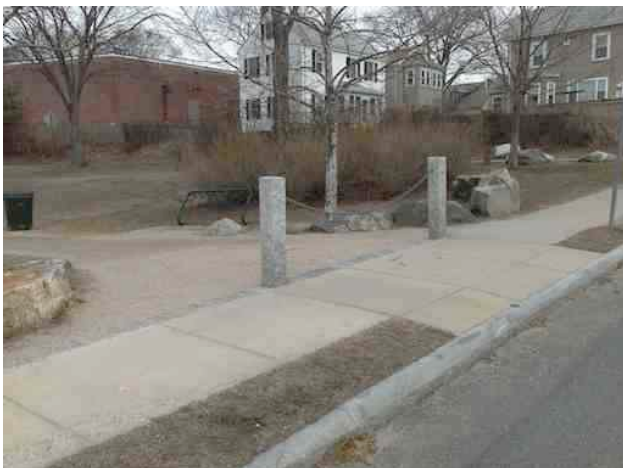
Photo 14

The chain-link gate between two bollards at the South Beach Linwood Circle entrance to the Shoreline path is not in itself an accessibility issue; however, the clear space on either side of bollards is not accessible because there are excessive slopes and counter-slopes; and, the ground surface is not level, smooth and slip-free. (Photo 14)

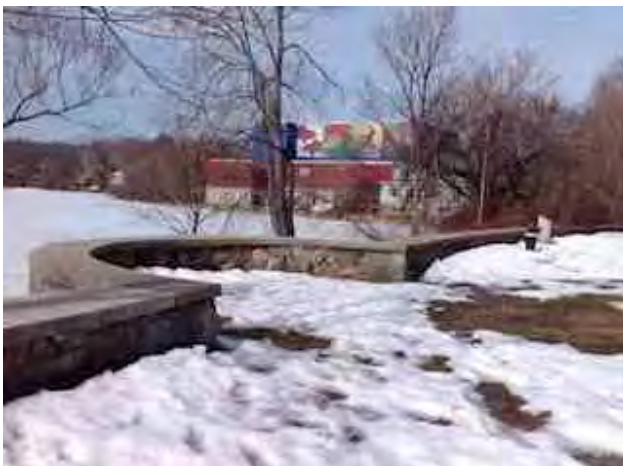
Photo 15

The Overlook area, dedicated in 1994, contains no accessible route to the public amenities in this area, including benches, signage, overlook bays, and memorial markers. (Photo 15)

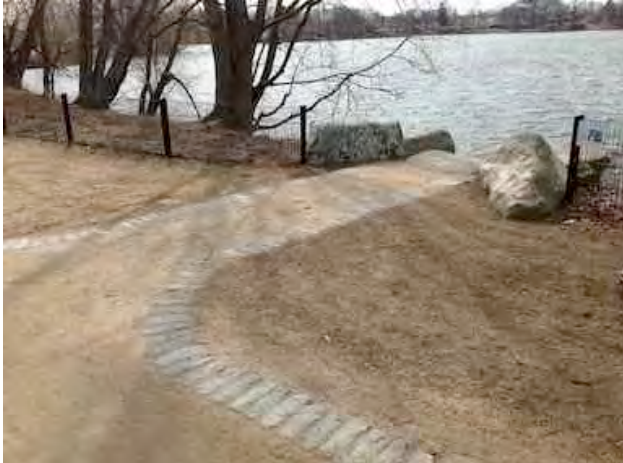
Photo 16

Viewing areas include well-graded paths. These need to be wide enough to provide turning-around space (minimum 5 feet unobstructed width). Due to lack of adequate width, these viewing amenities are not currently accessible, safe and usable. (Photo 16)

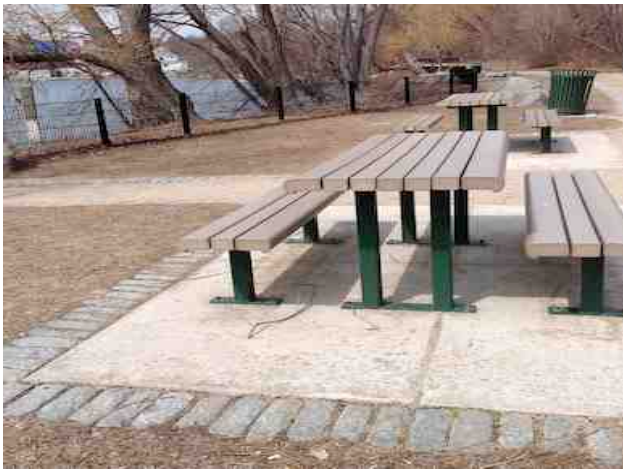
Photo 17

Picnic areas do not include accessible routes because the cobblestone edging is not smooth, level and slip-free. In addition, there needs to be a minimum four feet path to allow individuals using wheeled mobility devices to enter and circulate around the picnic table and bench amenities. (Photo 17)

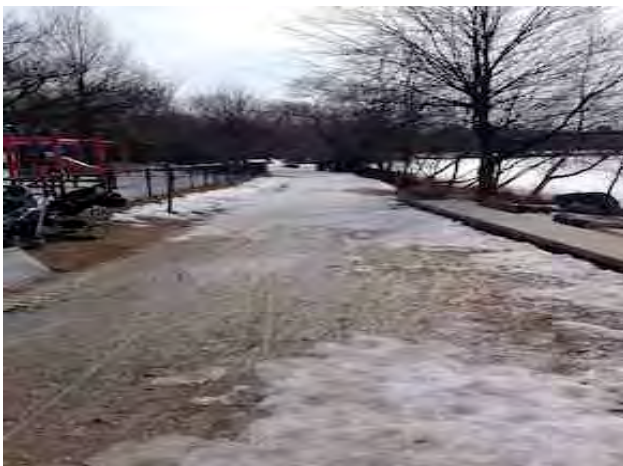
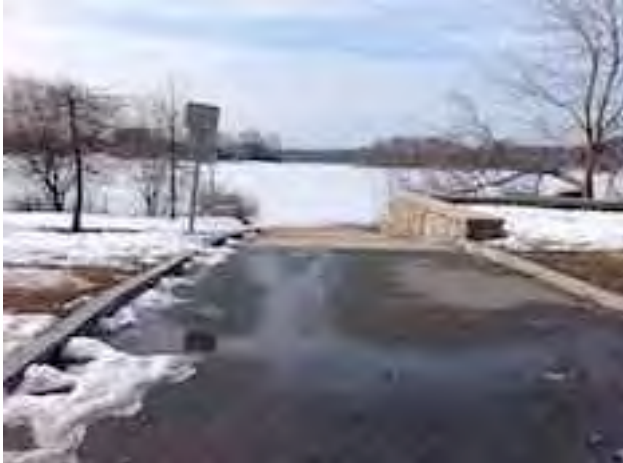
Photo 18

The shoreline path is well graded, clearly designated and includes ample passing space. Water accumulation, snow removal and ground surface displacement issues require regular and seasonal maintenance. (Photo 18)

There is an accessible walkway with smooth surface and minimal slopes leading to the Boat Ramp. However, important safety signage regarding use of this facility is located adjacent to the corrugated surface instead of adjoining an accessible clear ground space. (Photo 18)

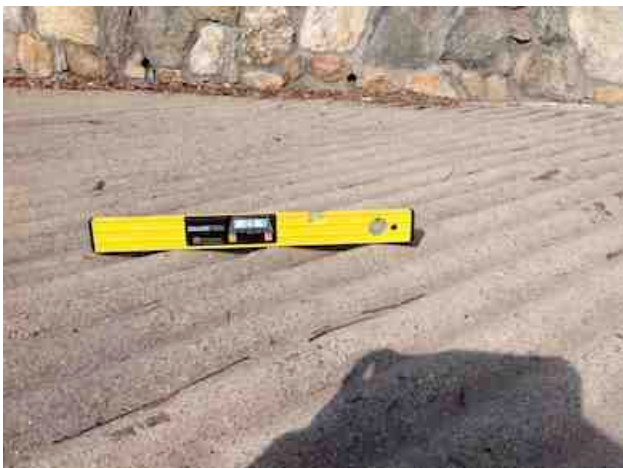
Photo 19

The construction of the Boat Ramp was completed without provision of an accessible route or inclusive adaptive sports programming. There is no provision of at least one 60-inch level boarding pier/launch dock for persons using mobility accessories to embark and disembark onto rowboats. There is no provision of a smooth walking surface. (Photo 19)

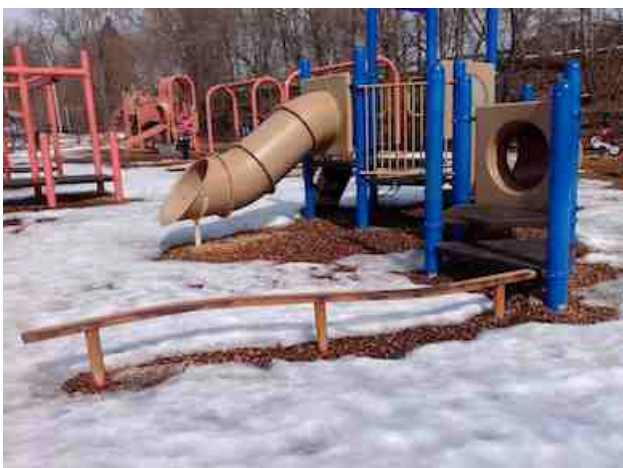
Photo 20

Play area loose fill surfacing materials do not maintain cross slopes not exceeding 1:48 (2.08%), and have uneven surfaces, with changes in level greater than 1/2 inch, and with openings greater than 1/2 inch *diameter*. A balancing ground play element extends into an otherwise clear circulation route and is not cane-detectable. (Photo 20)

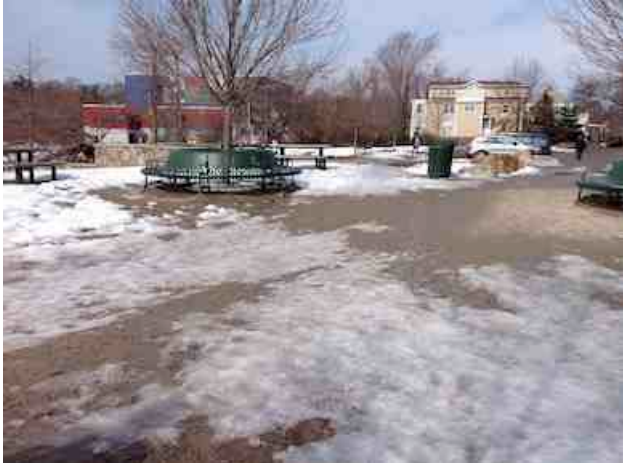
Photo 24

Seating areas, picnic tables, circle benches around a tree, trash receptacles and drinking fountains are provided through this linear facility, from north beach to south beach. These elements and amenities do not adjoin accessible routes and unobstructed firm, level ground spaces for integrated wheelchair seating are not yet included in seating and table arrangements. (Photo 24)

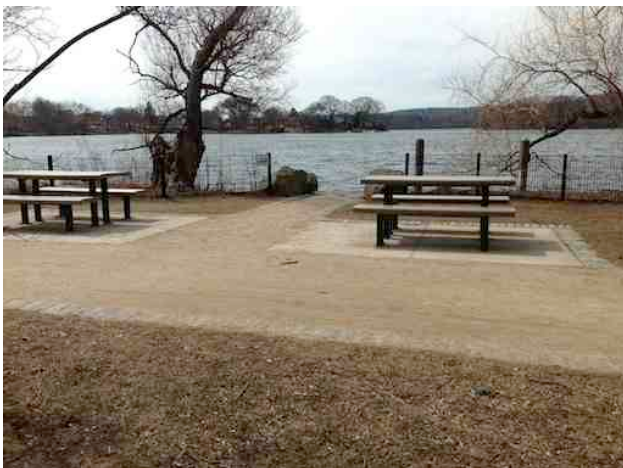
Photo 25

There are at least 7 picnic tables along the shoreline route from north to south. Tables are not connected to an accessible route. The ground surface under and around tables is uneven and slippery or, the level surface is not wide enough to accommodate an adjacent clear space of at least 30 inches by 48 inches along an accessible route. (Photo 25)

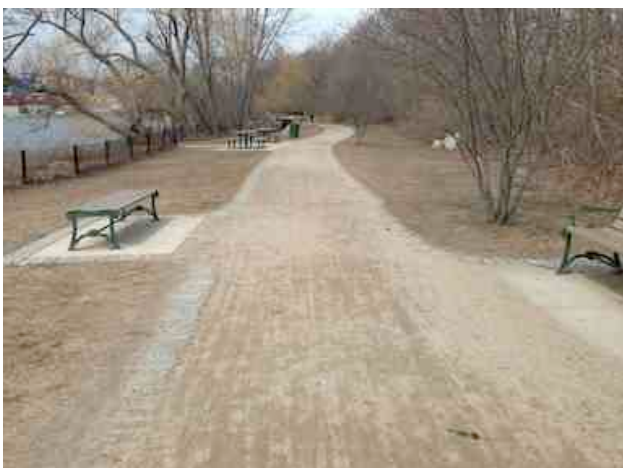
Photo 26

The benches are not connected by accessible route. The ground surface under and around benches is uneven and slippery. An adjacent clear space of at least 30 inches by 48 inches is not provided. At least one or 5% accessible benches at both North and South beach areas should be provided adjoining an accessible route. (Photo 26)

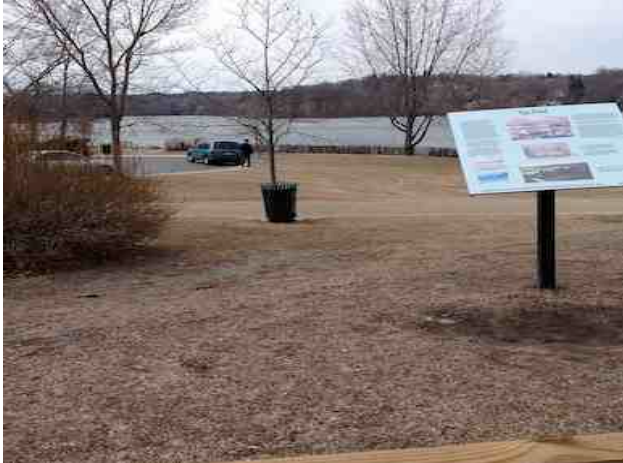
Photo 27

South Beach Sign installation is off the Bikeway path behind an erosion barrier. Sign is not accessible because ground surface to approach, view and read sign is not firm and slip-free. (Photo 27)

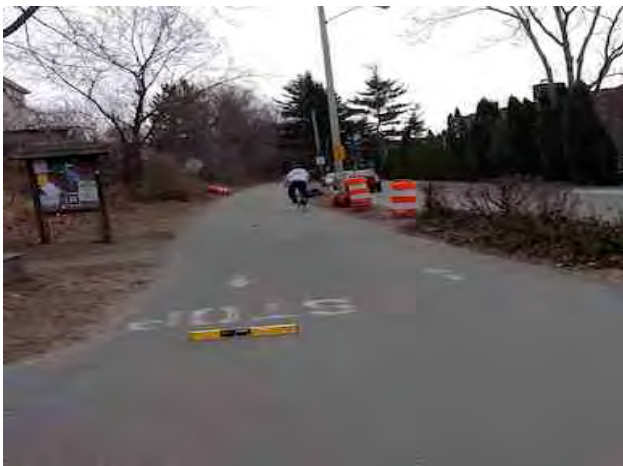
Photo 29

A community bulletin board at South Beach Bikeway connection does not provide an accessible forward approach to view and post community information signs. (Photo 29)

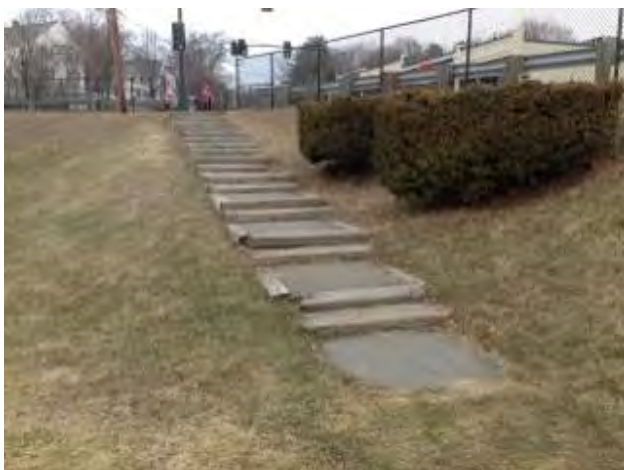
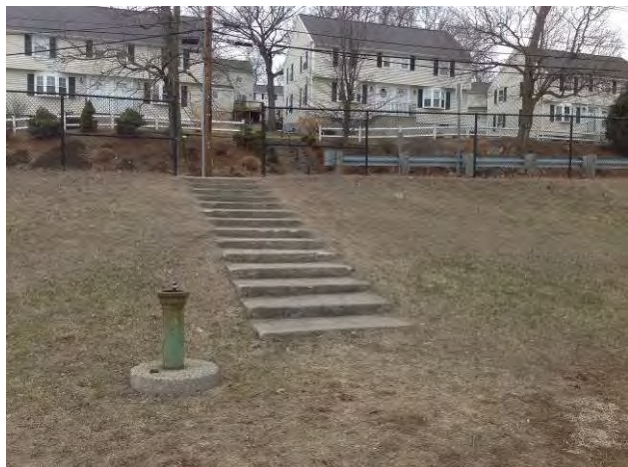
Photo 3

On Summer and Forest Street, stairways are in poor condition and are missing compliant railings on both sides. (Photos 3 and 4)

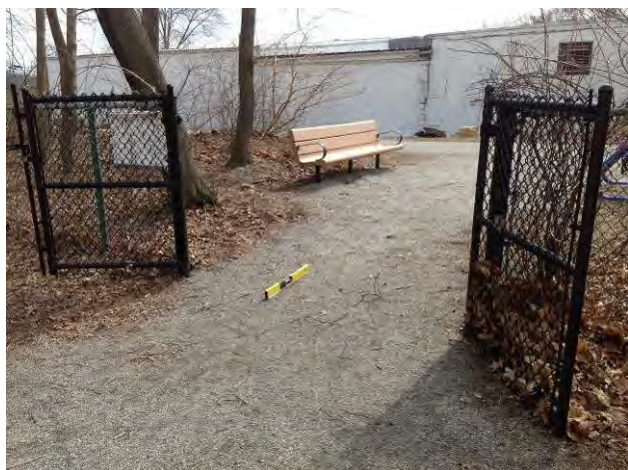
*Photo 5*

Along the Minuteman Commuter Bikeway, the asphalt walkway that leads to the multi-generational activity area has excessive running slopes (7%) and the asphalt walkway that leads to the parking adjacent to Ed Burns Arena is poorly maintained. (Photo 5)

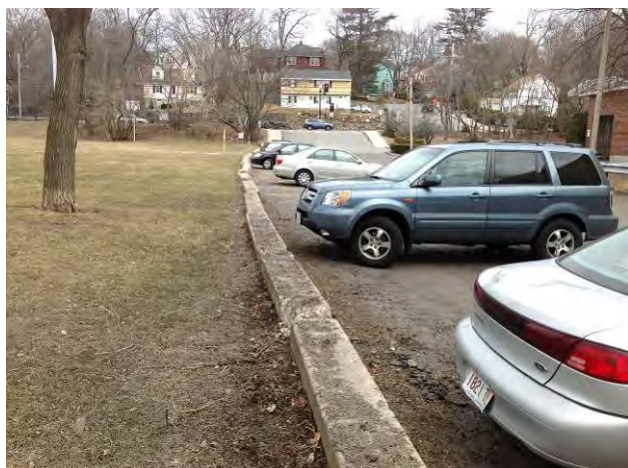
*Photo 6*

No accessible parking spaces serving this facility were identified in the marked parking spaces adjacent to Summer Street Park. (Photo 6)

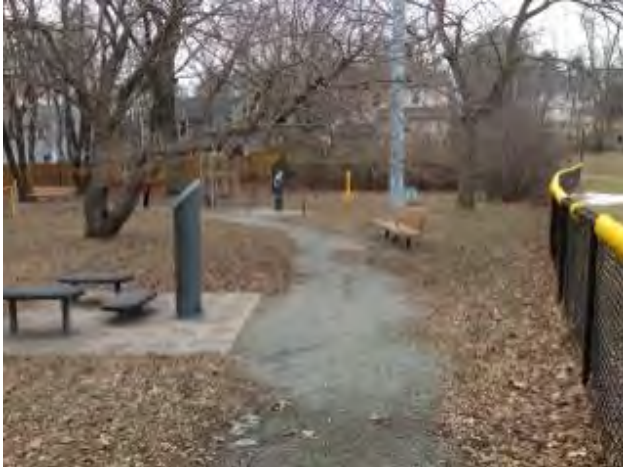
Photo 7

A stone walkway is provided between the parking lot adjacent to Ed Burns Arena and most features within the multi-generational activity area. In certain areas along the fitness course, tree canopies protrude into the circulation path, hanging less than 80 inches above the ground. This obstructs pedestrian vertical access from being continuous from one end of path to the other.

(Photo 7)

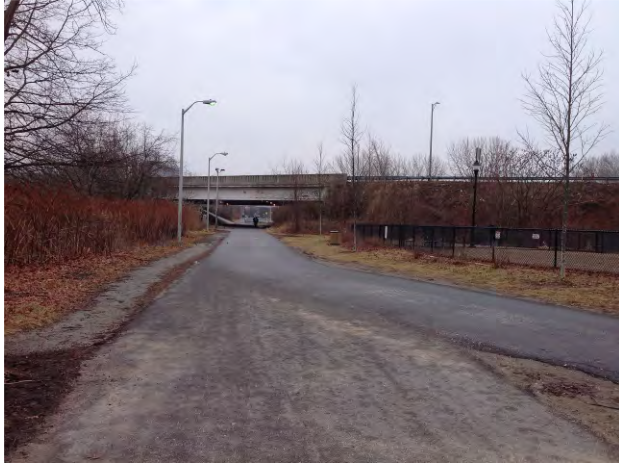
Photo 1

A stone path is provided between the parking lot and points of entry at the intersection of the parking lot and the Minuteman Commuter Bikeway. However, this path is in poor condition and is uneven, unstable, and steep at certain sections. (Photo 1)

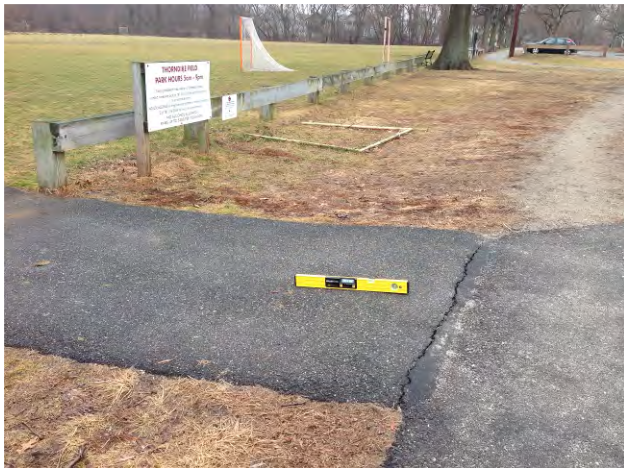
Photo 2

At the intersection of the parking lot and the Minuteman Commuter Bikeway, the asphalt walkway that leads to the grassy field has excessive running slopes (9.5% at the intersection with the bike path). (Photo 2)

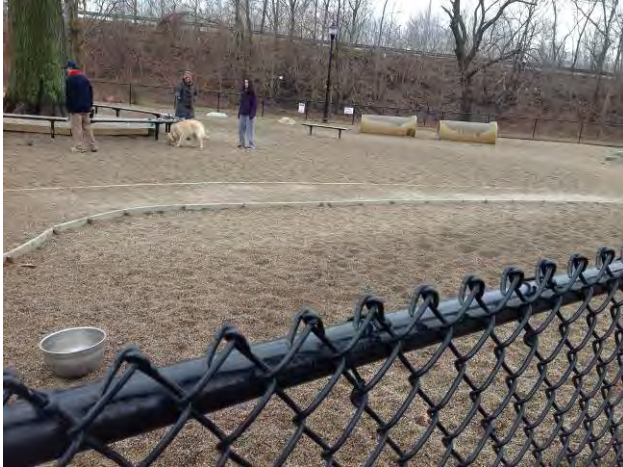
Photo 4

Inside the dog park, a paved walkway is provided between both points of entry to the enclosed area. However, due to the lack of curb along the walkway as well as intense activity of animals, sediments from the adjacent gravel areas can make the ground surface slippery. (Photo 4)

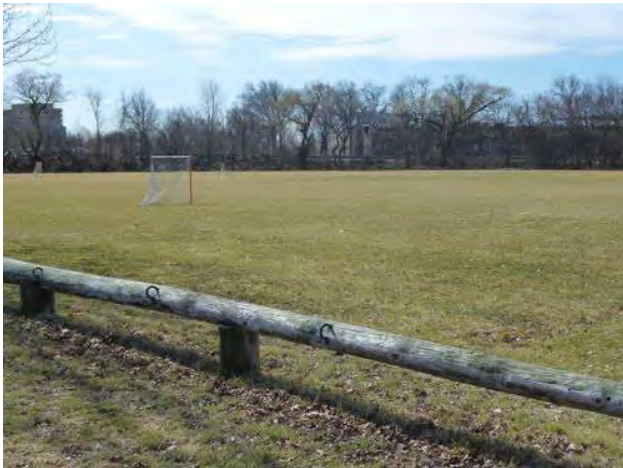
Photo 5

Although an asphalt walkway is provided between the Minuteman Commuter Bikeway and the edge of the grassy field, it does not extend to the boundary of the soccer and lacrosse fields. (Photos 5 and 6)

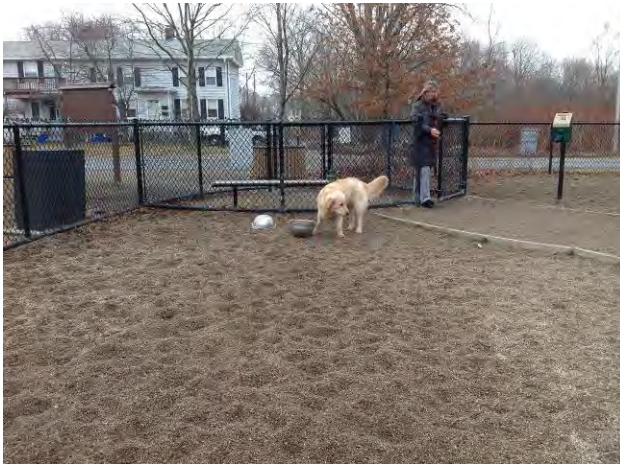
Photo 8

Inside the dog park, amenities including dog play structures, water spouts, and trash bag dispensers are provided along the walkway. Neither feature is accessible because they do not adjoin an accessible route. (Photo 8)

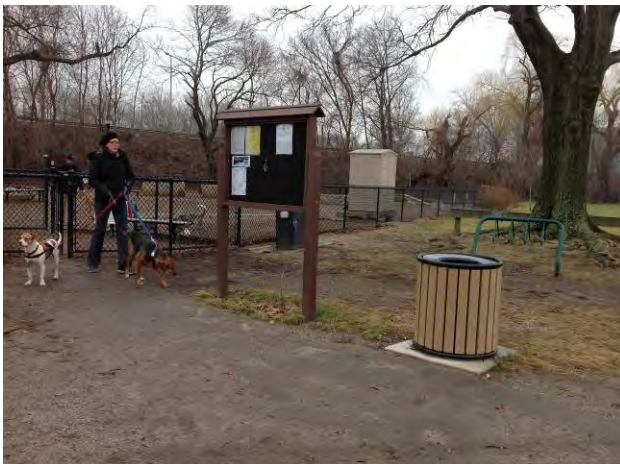
Photo 9

A bulletin board is provided near one of the points of entry of the dog park; however, it is not located within an accessible route. (Photo 9)

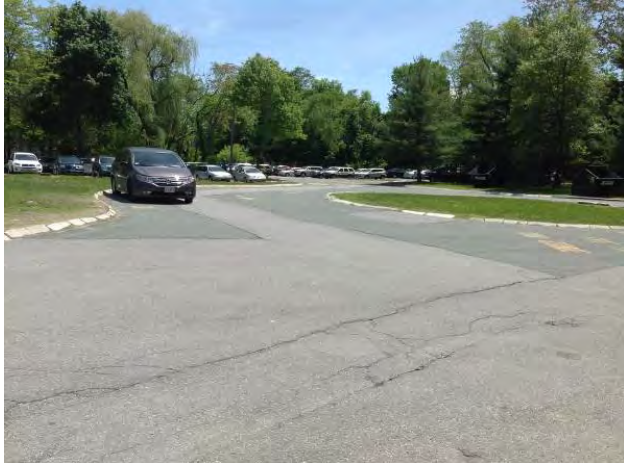
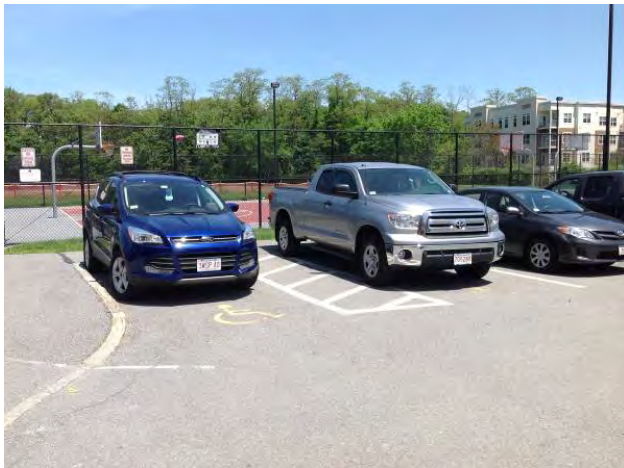
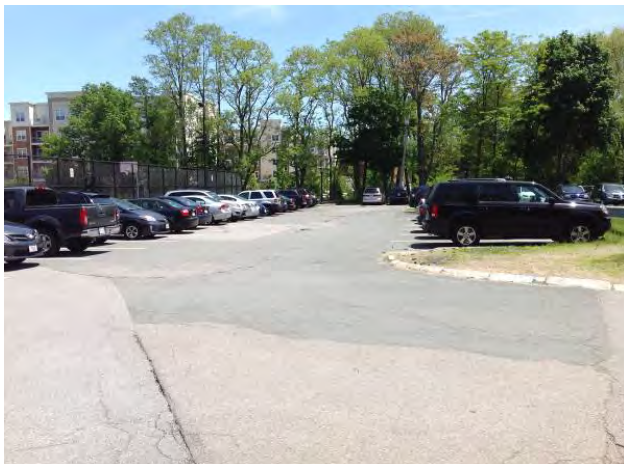
Public parking facility at Millbrook Drive has approximately 50 spaces, with two designated as accessible. The shared access aisle lacks the necessary width for van-accessible parking. (Photos 1, 2, 3)

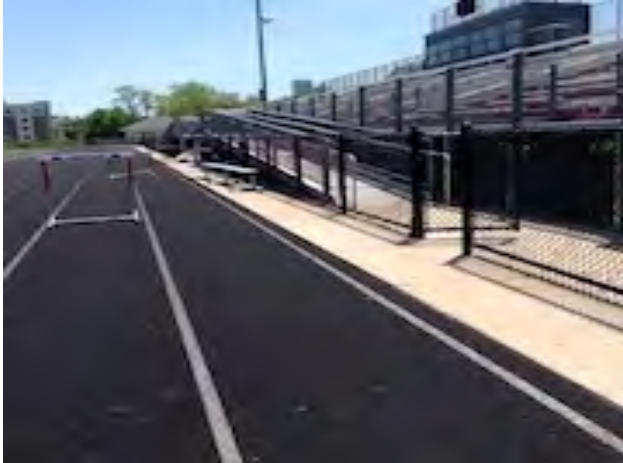
Photo 4

The Track and Turf Fields provides accessible route to sports areas and use of track. (Photo 4) Entrance to ramp from public point of entry to grandstands is over 100 feet. Walkway adjacent to track ends five feet after fence onto a hilly grassy slope, approximately 290 feet from spectator ramp. There needs to be a clear emergency egress route map and plan for this facility in case of any emergency, so that individuals using wheeled mobility devices have adequate access to clear emergency egress routes leading to safe places of refuge. (Photo 5)

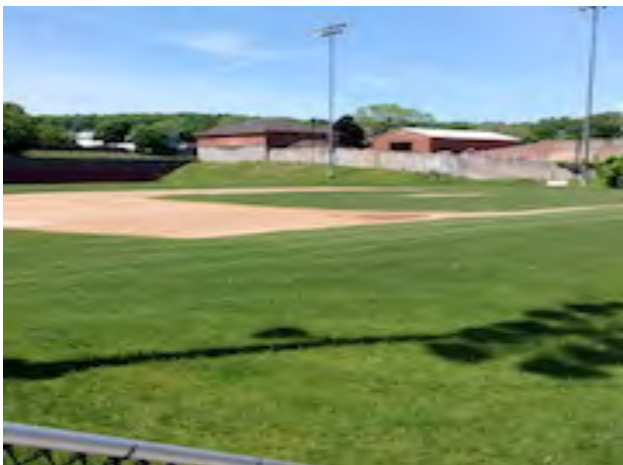
Photo 6

Although ball field nearest to high school parking area includes bleachers and team seating on concrete platforms, these platforms do not extend to join an accessible route, and they do not provide a clear location for integrated seating at team seating and at bleacher areas.

There is no accessible route to the boundary of the sports playing areas. (Photo 6)

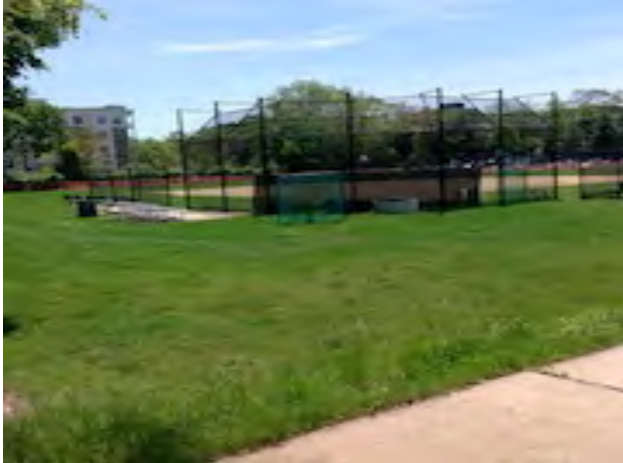
*Photo 7*

Although ball field to the east of track includes bleachers and team seating on concrete platforms, these platforms do not extend to join an accessible route, and they do not provide a clear location for integrated seating at team seating and at bleacher areas.

Smaller practice field south of east field does not have team seating area or bleacher area. There is no accessible route to the boundary of the sports playing areas for either of these fields. (Photo 7)

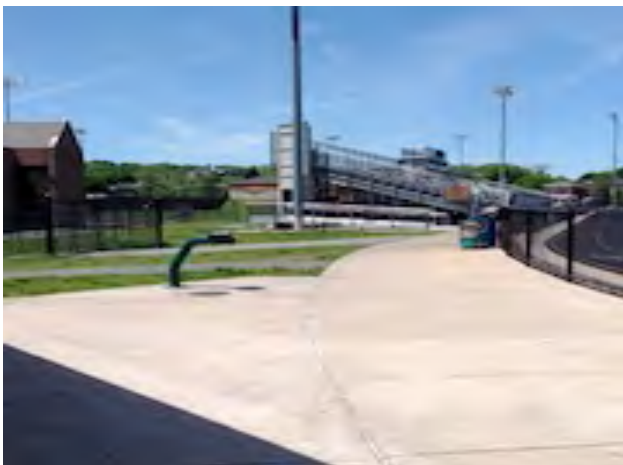
*Photo 9*

Drinking fountain is along an accessible walkway and allows for accessible forward approach. Cross slopes near fountain are slightly excessive. (Photo 9)

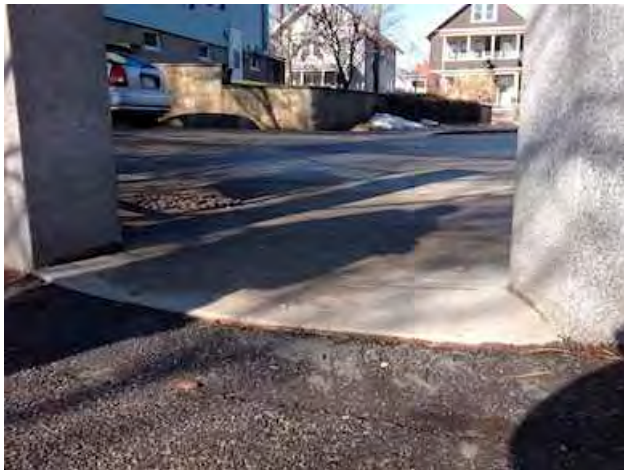
Photo 2

Curb ramps at Intersections near the Teel St. entrances do not connect with accessible sidewalks, have steep slopes and are missing level landings. New curb ramps at the Waldo Road/ Amsden intersection are incorrectly constructed as apex instead of perpendicular and lead users into road instead of along sidewalk route. (Photo 2)
